Overview

DATA SHEET

Cleaning Process

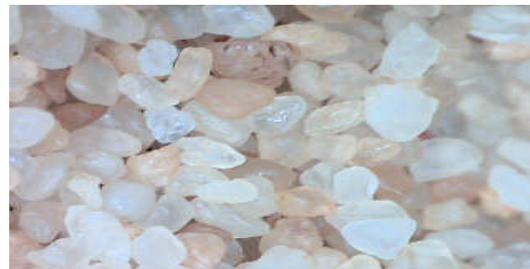
New Sand

Topline took samples of sand 10 years old, this sand after cleaning was placed under a digital microscope and compared with new sand.

It can be seen from the comparison of the two samples that there is no visible rounding of the sand. This test was repeated on several samples from different filters with similar results. It can therefore be concluded that **sand does not age. This being the case sand does not need changing just cleaning.**

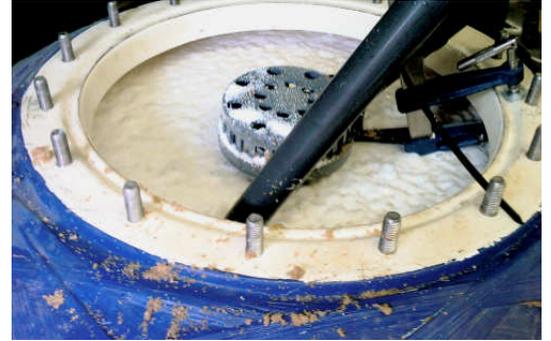
To clean the sand, the filter is isolated from the filtration system. The lid can then be removed and the filter filled with water. The “Silica Wash” is added to the filter and the filter sand agitated using a high capacity pressure pump.

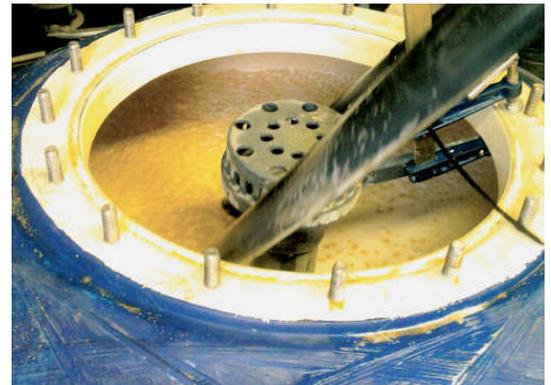
During the agitation process the body fats are lifted from the sand, this can clearly be seen on the below picture.
